4. Historic Building Recording within Warburton

4.1 Introduction

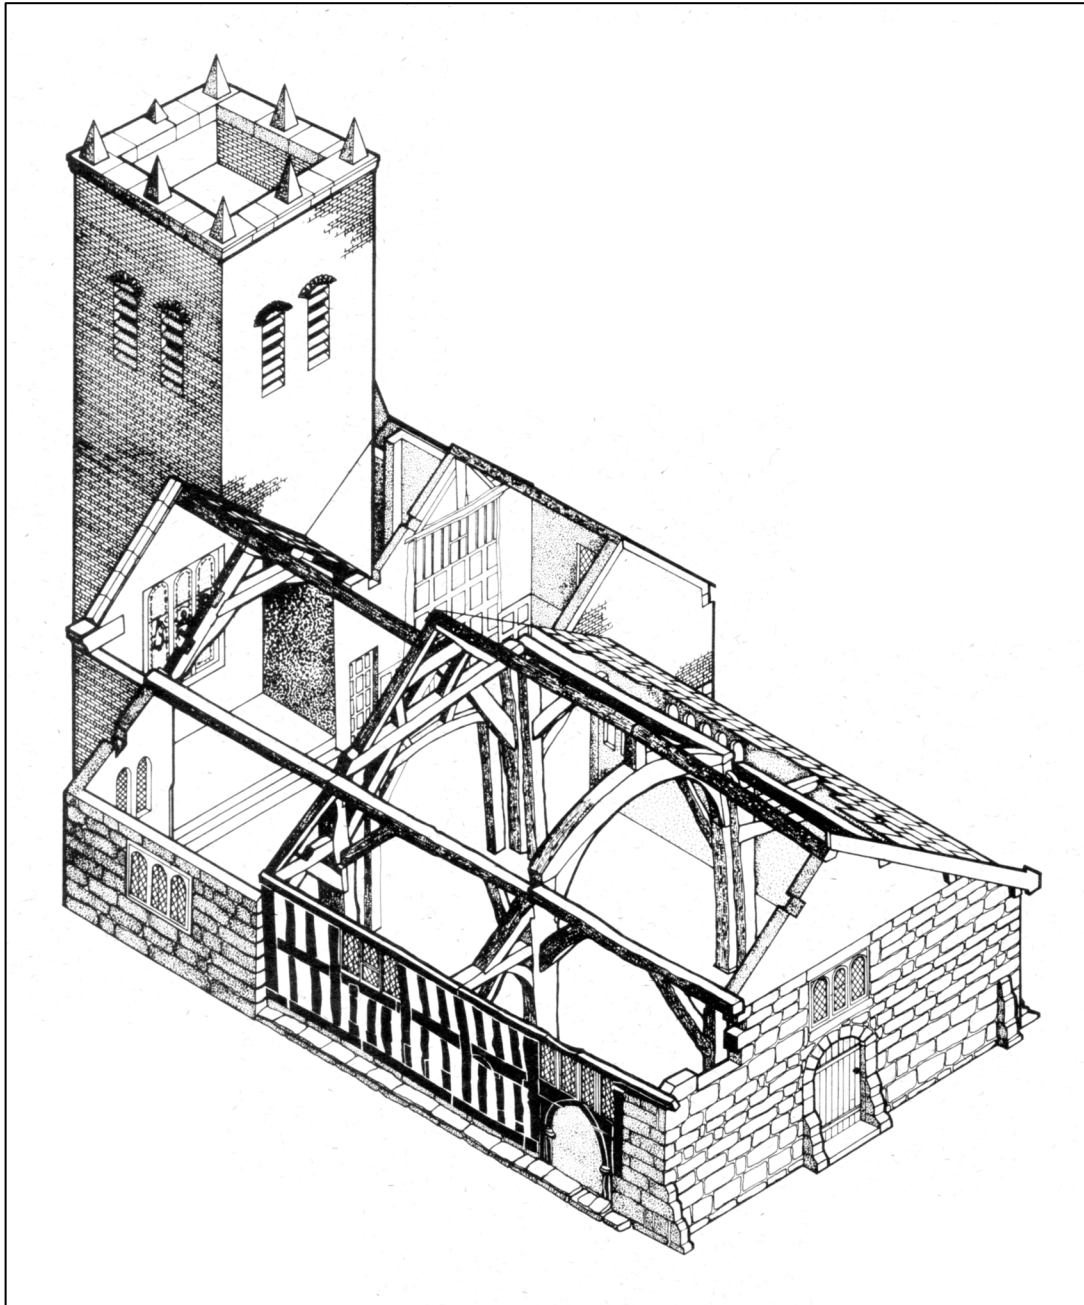
Figure 88: 3D view of St Werburgh's old church showing the late medieval timber trusses and timber-framed northern wall.

A timber-framed parish church, first mentioned in the twelfth century, on the north-western side of Wigsey Lane. Set in a curvilinear, D-shaped graveyard, defined by a low bank c 1m high and c 2m high. This boundary was surveyed in 1988. A Level 2 survey was undertaken in 1988, and a Level 3 survey and dendro analysis in 1998.

The listed building description is as follows: 'The Church, now redundant. Ancient structure mostly re-constructed in the second quarter of 17th century; north aisle late 16th century; west front and south aisle dated 1645 (a Victorian replacement for an earlier datestone), north transept late 16th century, chancel and vestry early 17th century, sanctuary and tower (at east end) 1711 on keystone. Ashlar sandstone, English Garden Wall bond brick except for chancel which is Flemish bond, timber internal frame, timber-framed north aisle and graduated kerridge stone slate roof. Nave with aisles under same roof, and west door. South aisle has datestone over blocked door leading to former gallery; one 5-light and one 2-light double-chamfered mullion window with semi-circular heads and one 2-light chamfered window of a later date. Brick chancel aisle is roofed axially, built off a stone plinth and has a 3-light flat-faced mullion window. The square tower has 2 semi-circular brick arches at belfry level, stone eaves cornice and 6 sugarloaf pinnacles. Its east face has a semi-circular headed doorway with dated keystone and oval light above. West end has 4 buttresses little higher than the projecting stone plinth. The central studded and cross-battened door has a chamfered semi-circular head and 3-light window above (as above). North aisle of 2 bays, close studded with middle rail with plaster infill on a stone plinth each with a 3 or 4-light timber mullioned leaded light and a blocked doorway (formerly to gallery) in bay 3 with semi-circular head and carved responds. Chancel projects slightly with coped gable and kneelers and a 3-light east window. Interior: 2-bay nave in which massive arcade posts support a tie-beam truss and an arcade plate both with diagonal braces. These posts have many redundant slots, some of which relate to a gallery built in 1722 and removed in 1857, and accessed from a blocked door in the southern wall. Where the chancel meets the nave a group of 3 posts on the north and 4 on the south give evidence of various periods of construction/repair. 3-bay chancel has braced tie-beam truss with diagonal struts and 2 arch-braced collar trusses. Bell dated 1575. Octagonal font inscribed "William Drinkwater the Keeper 1603". Jacobean pulpit, altar 1645 and 17th century turned-baluster altar rail which was adapted to accommodate the choir seats in 1857. Box pews 1813. Stained glass east window by Wailes, and Minton sanctuary floor tiles both 1857. The Vestry was added in 1822. Sarcophagus maybe 12th century. There is a sundial south-west of the church in the graveyard with 1765 (on dial). Stone with copper dial and gnomon. Baluster-type shaft with square head and base. 17th and 18th century graves are recorded from within the nave and chancel, whilst there may also be a vault immediately in front of the altar rail. The building was extensively repaired in 1927 because of the activities of deathwatch beetles, with the aid of the Ancient Monuments Society and included re-used timbers from Birch Hall in Rusholme. In 1958 further repairs, also because of death watch beetle, were necessary to the chancel and roof of the nave (Dodgeson 1970, 34-5; Faulkner 1989, 42-58; Newton 1939; *Transactions of the Manchester Natural History & Archaeology Society* 1877-8, 38-40, 1896, 54-5 & 1907, 65-6; Warburton 1970, 25-44; Raymond Richards, *Old Cheshire Churches*, 1973).'

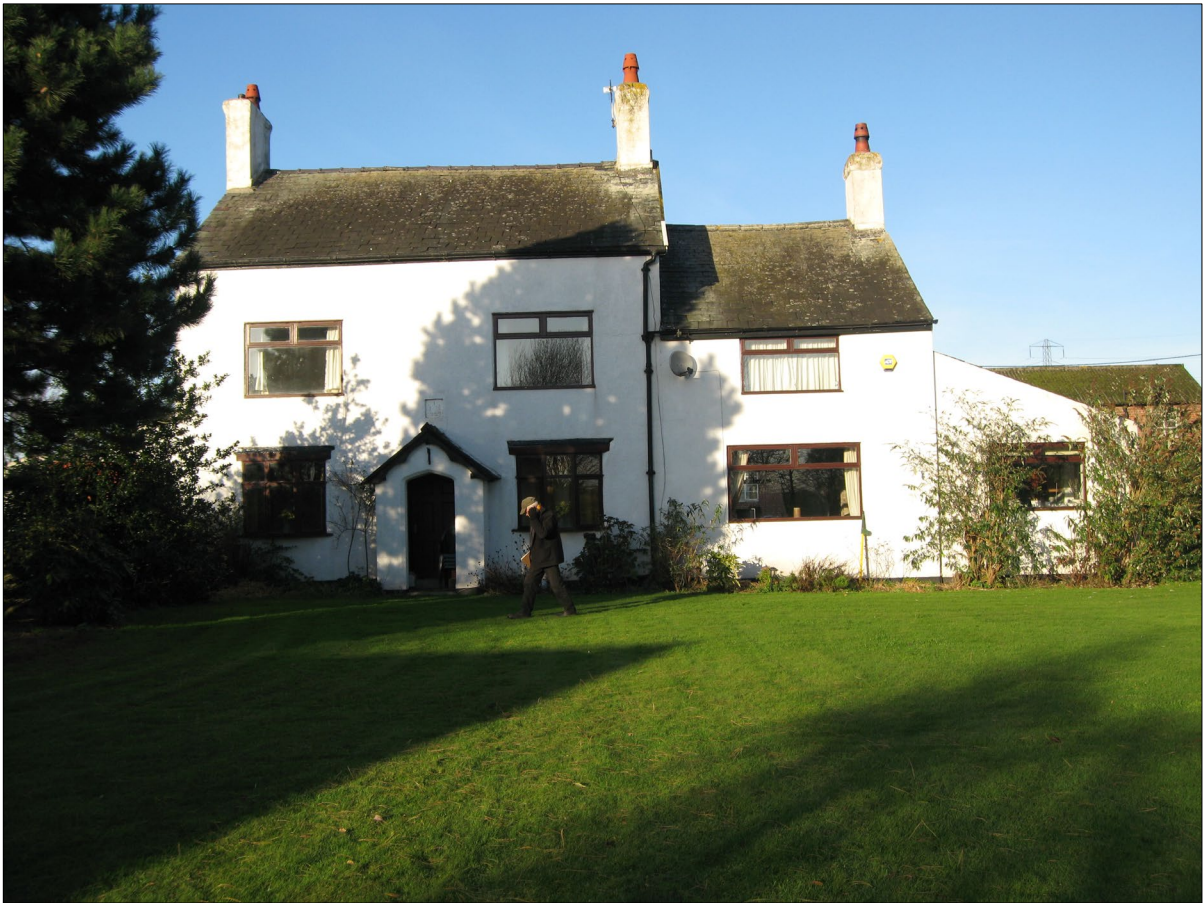
Figure 116: Lower Carr Green Farmhouse southern elevation and plan.

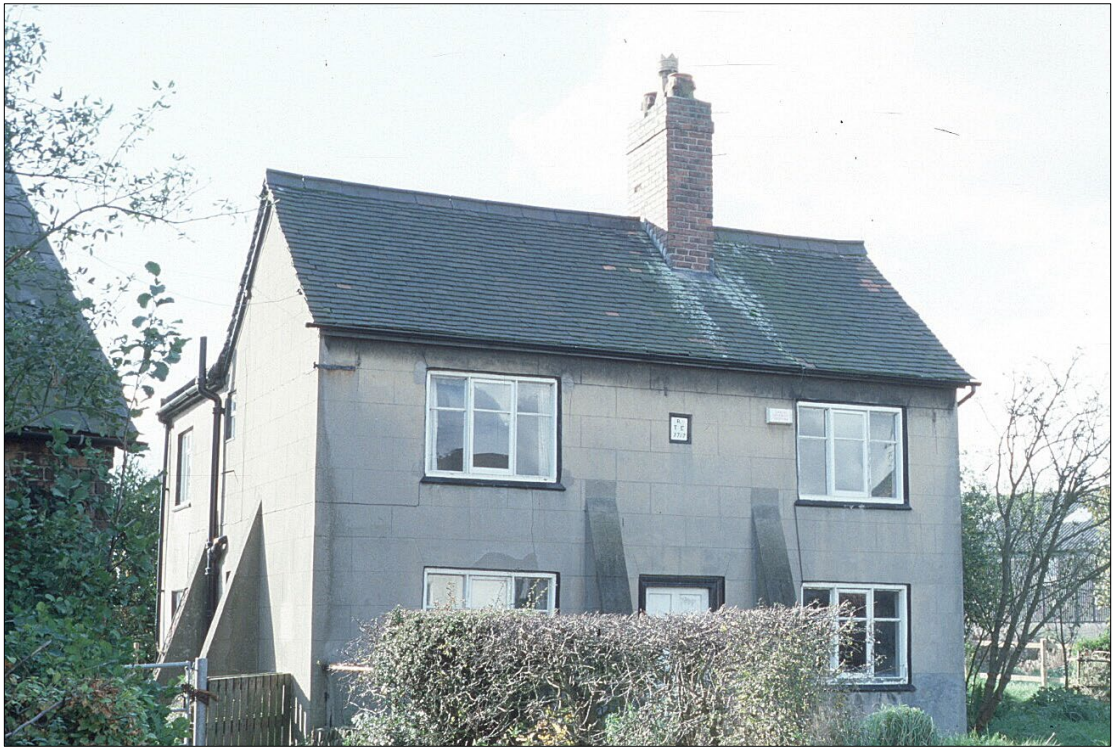
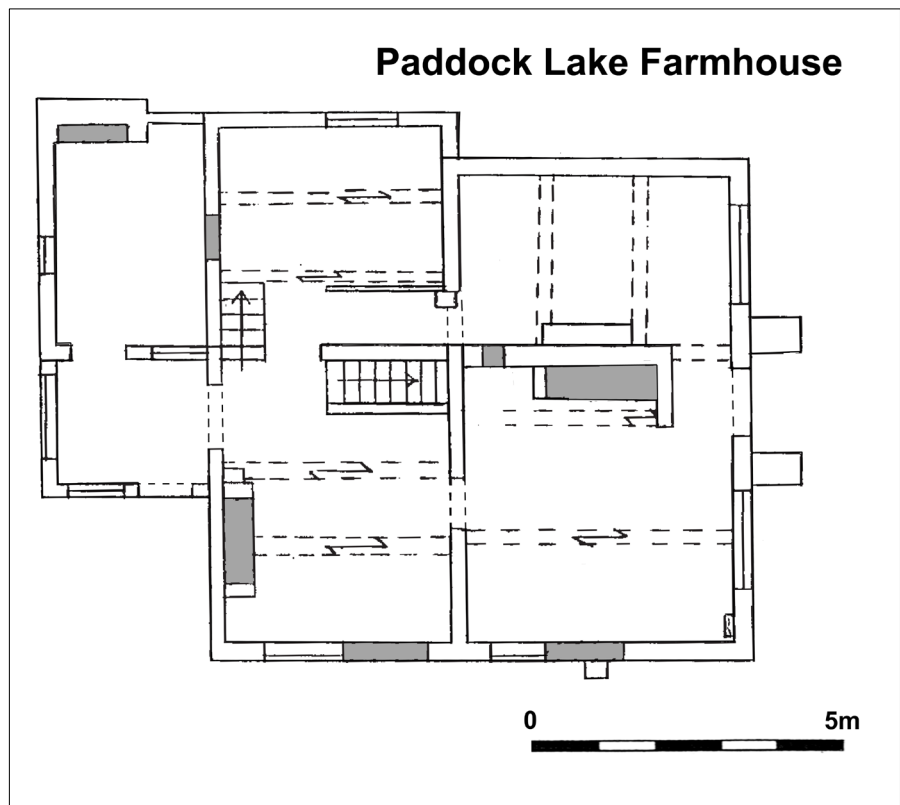
Figure 118: Paddock Lake Farmhouse northern elevation and plan before renovation.

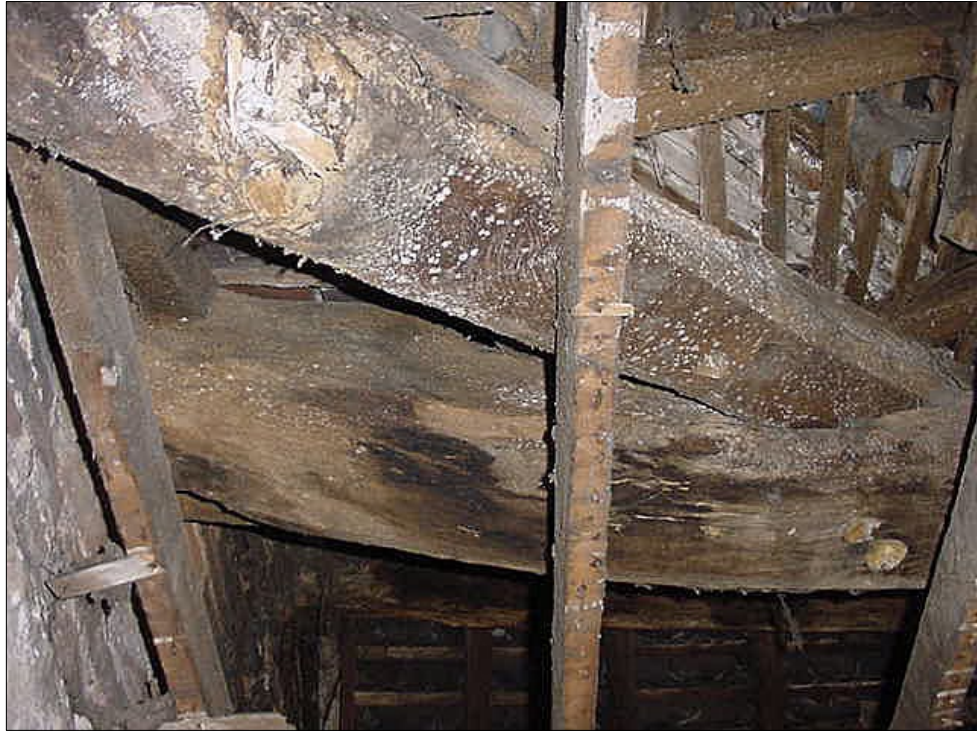
Figure 119: Re-used cruck blades in the roof at Paddock Lake Farmhouse.

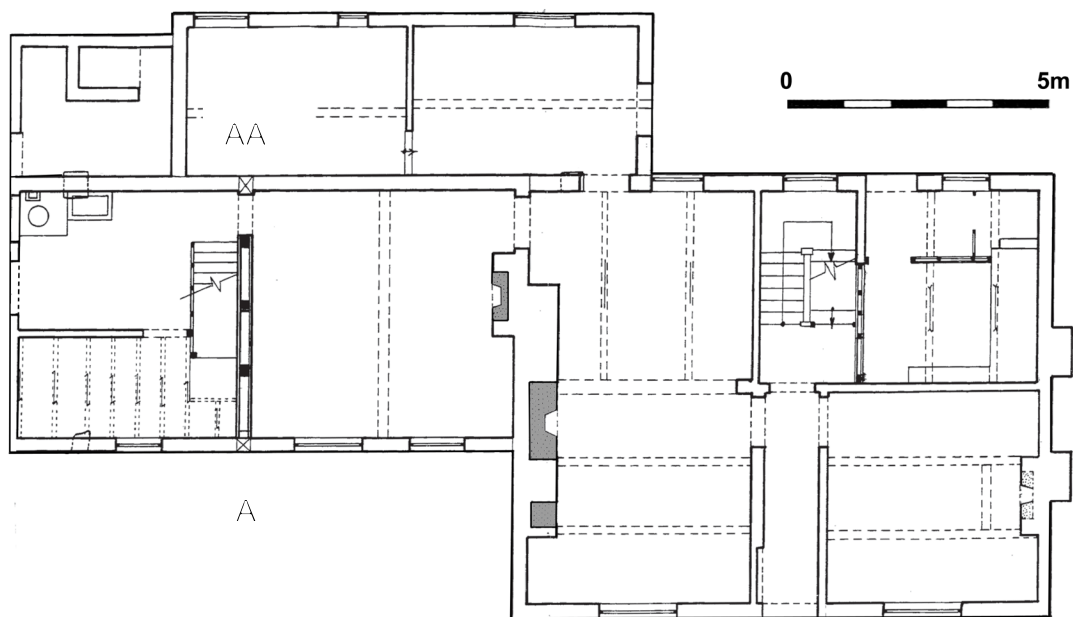
Figure 121: Southern elevation and ground floor plan of Paddock Lane Farmhouse.

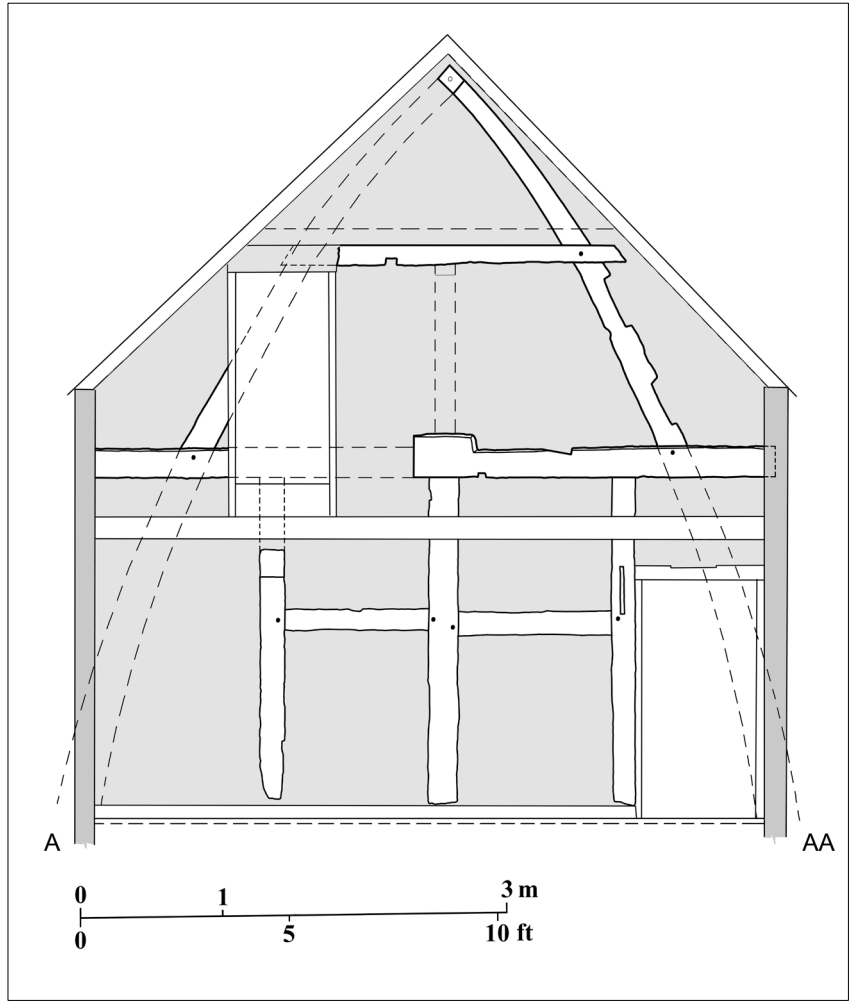
Figure 122: Cross-section and detail of the cruck truss at Paddock Laner Farmhouse.

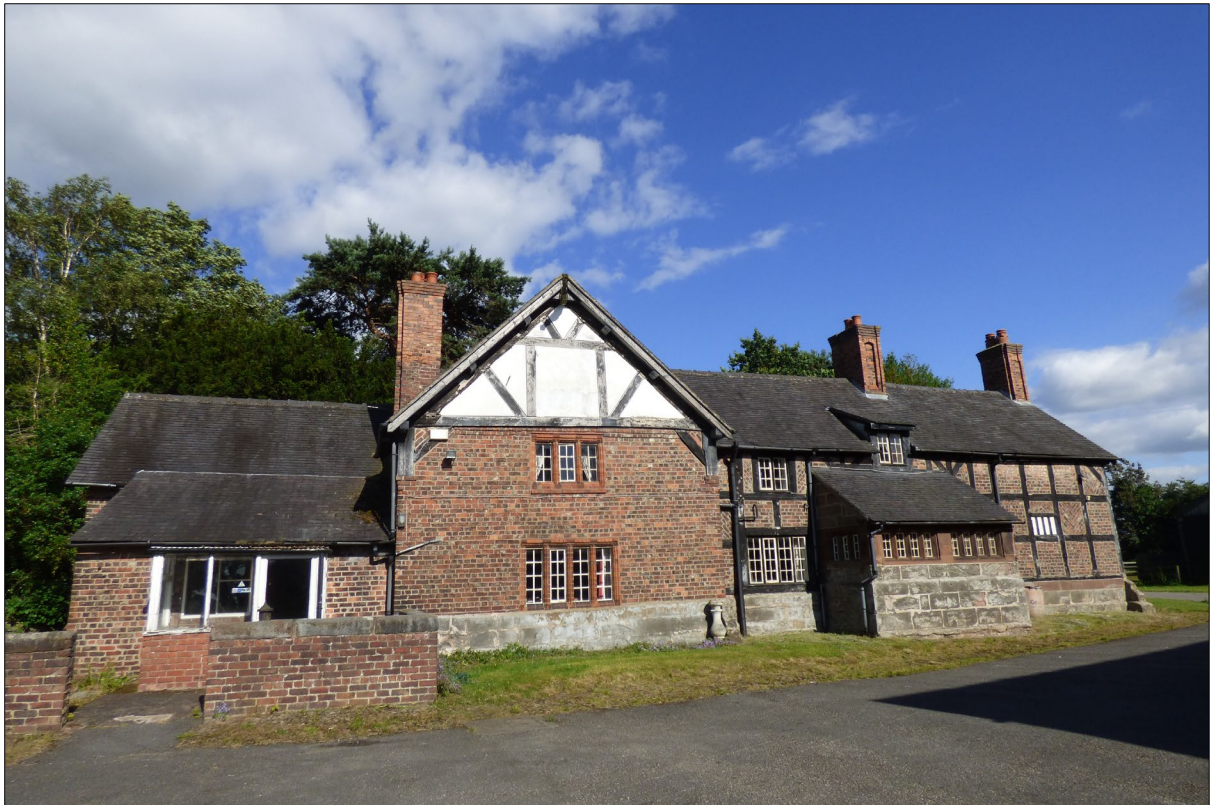
Figure 125: Western elevation and ground floor plan of The Bent.

Cruck barn to the south-west of The Bent farmhouse. Probably pre 1600 (i.e. the date of farmhouse), cruck framed with stone plinth, remnants of wall frame otherwise brick with clay tile roof (replacement for thatch). 4 pairs of crucks (3 bays) now with 2 storeys throughout with doors in north side; lean-to at rear and 3-bay cart shed at right (15m x 5m). Stone plinth and square panel frame remnants remain in bays 1 and 2. 3 doors and 2 dormer loft hatches. The cart shed is supported on 17th century posts with braces, otherwise it is 20th century in date. The 4 crucks are largely complete each having a tie beam or cruck spurs, collar beam and curved wind bracing. Framing to the right gable can be seen from inside only. Level 2 survey in 1997.

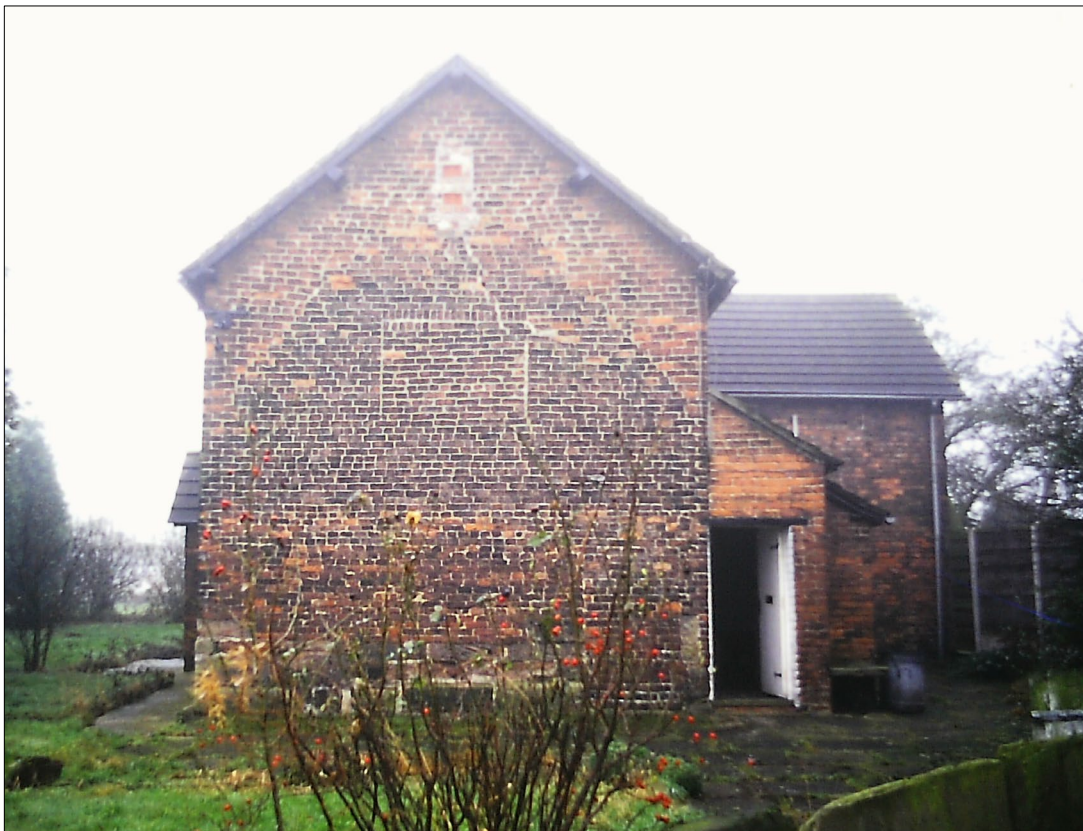
Figure 131: The northern gable of Wigsey Farmhouse showing the earlier roof line and blocked window.

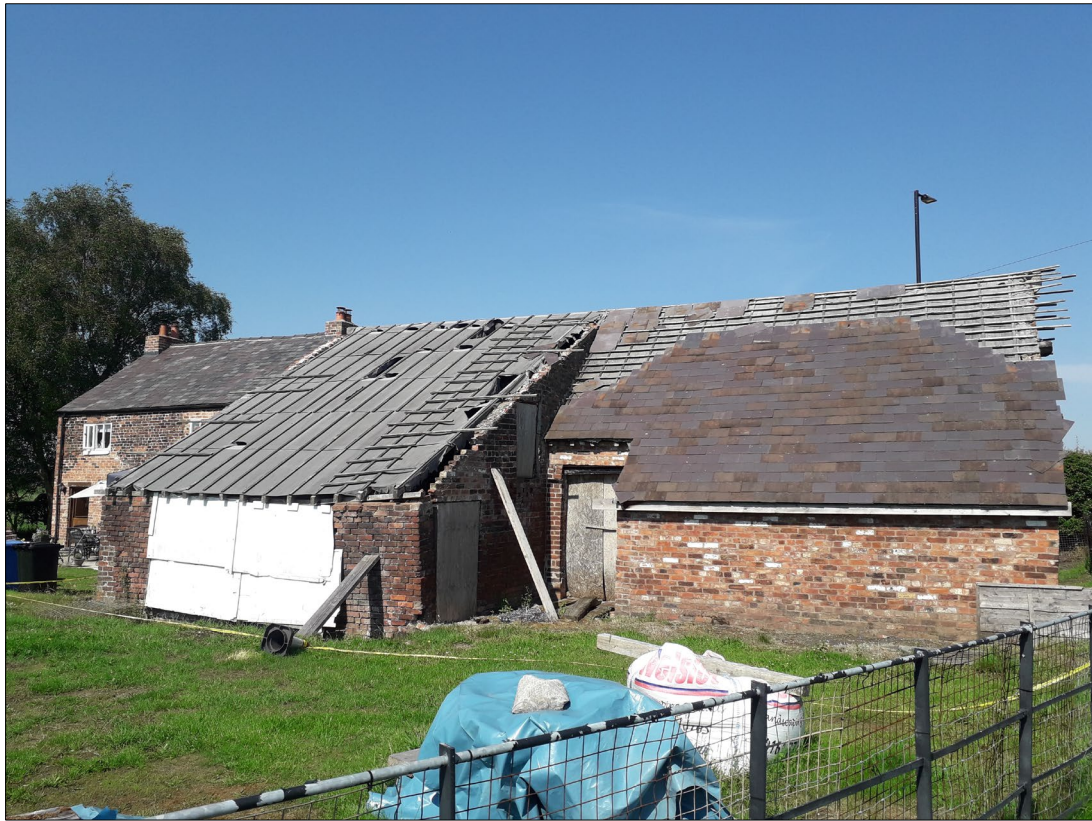
Figure 140: Heathlands Farm cruck barn plan and eastern elevation.

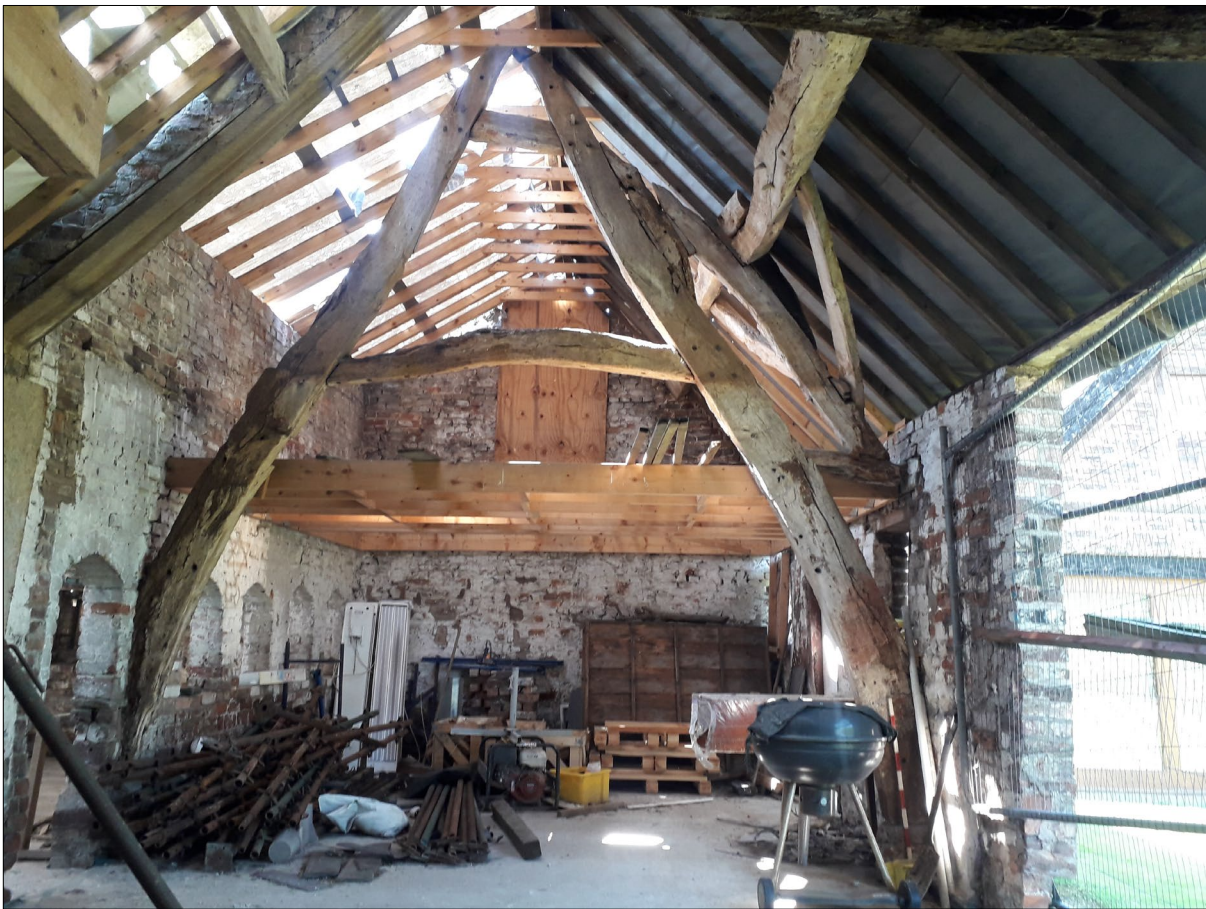
Figure 141: The cruck trusses at Heathlands Farm barn.

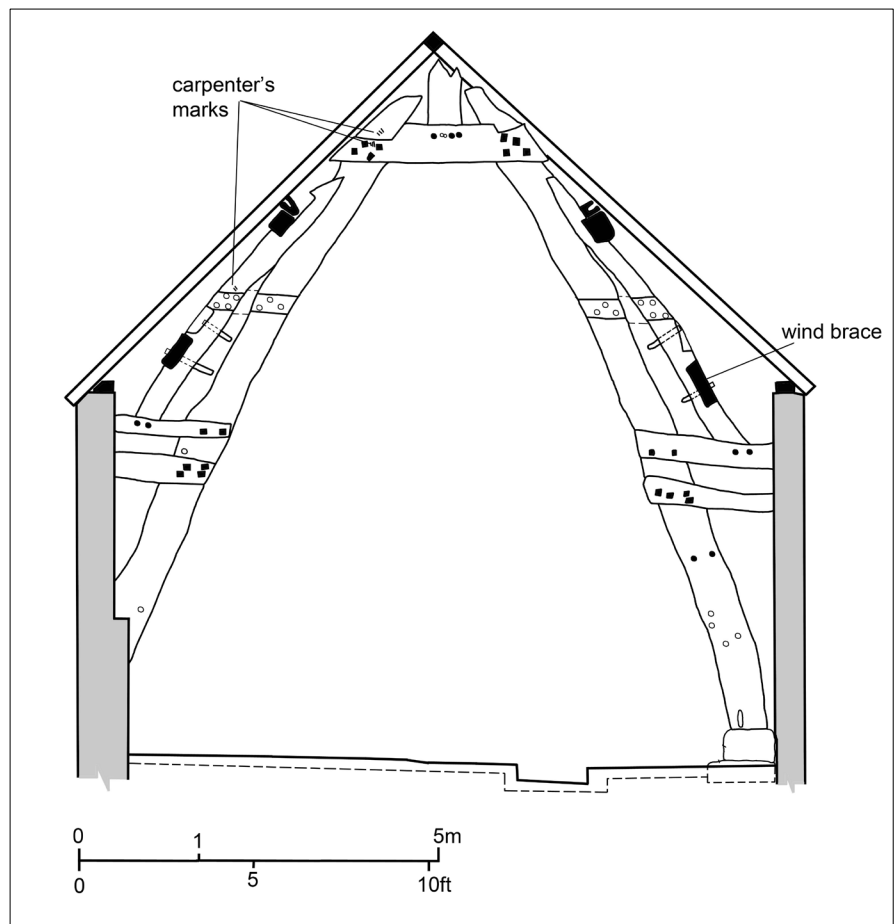
Figure 146: The two cruck trusses at Wigsey Farm barn.

The most significant of the cruck buildings studied in Warburton so far is Wigsey Farm where the presence of two cruck buildings of different styles, finish, and thus probably date makes the farmstead an important one for the study of the development of cruck construction in the county from the late medieval period to the 17th century. Probably the earliest of these two buildings is represented by two surviving pairs of cruck trusses in a shippon (now a domestic dwelling) to the west of the farmhouse. Carpenters' marks on these trusses indicate that the building was originally of two bays formed by three pairs of trusses, although only the northern two pairs of crucks survive. Internal evidence shows that this building was originally open to the roof. The date of this building is difficult to assess without tree-ring dating but the form of the apex and the overall condition and finish of the cruck trusses suggests a date in the 15th or 16th centuries. Although only one pair of cruck trusses survived in the nearby Wigsey Farmhouse (a two bay cruck building of the 17th century comprising an open housebody, containing an inglenook, and two service rooms) enough evidence remained to show that this building was constructed using younger and inferior oak timbers, as well as using re-used timbers, when compared to the nearby barn.

renovation work at Wigsey Farm (SJ 7007 8953), an ancient farm complex comprising a cruck farmhouse, a cruck barn with later brick shippon, a brick hay barn, and two twentieth century steel-framed hay barns. The cruck was photographed and a phased plan produced. Annotated drawings of the architect's elevations were also produced and these have been deposited in the site archive. The barn had four recognisable phases, the earliest being represented by the two surviving crucks which possibly date from the 16th century. This was expanded in the 18th century as a cart shed with loft above, and in the 19th century was converted into a milking parlour. The complex is particularly noteworthy for the juxtaposition of two cruck-buildings of different quality and date.

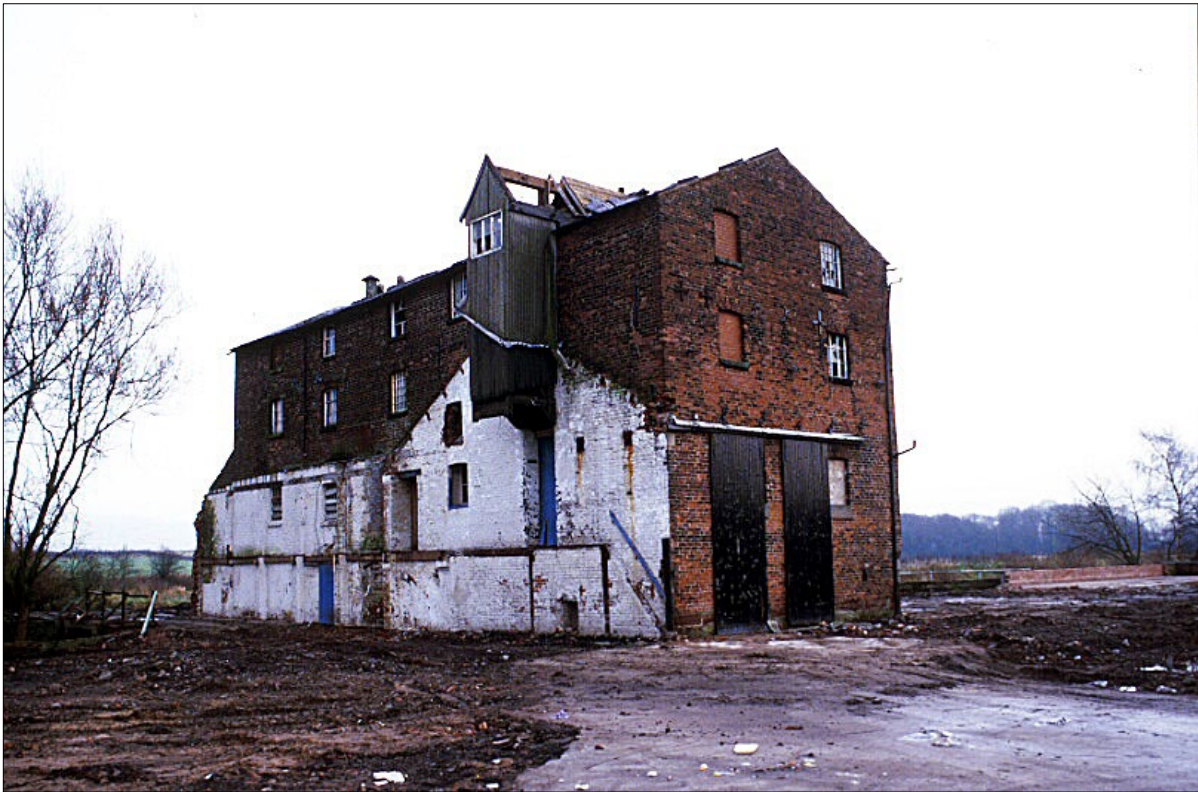
Figure 149: Plan and exterior elevations of the early 19th century mill block at Warburton Corn Mill.

Perhaps the most important building to be rebuilt in brick during this period was the cornmill. Until demolition in 2000 the standing remains at Warburton Mill covered the period from the late 18th century to the mid-20th century, spanning the mechanisation of flour-milling that took place in the late 19th century. This represented the transition to steel rollers and the introduction of advanced water-turbine technology.

The earliest and largest part of the complex to survive was the brick four-storey milling building, the heart of the site. A building was present at this location on the estate map of 1757 and is recorded in this area in the 14th century. However, the design of the mill building surviving in 2000 included the use of cast-iron columns and heavy wooden floors suggesting a late 18th/early 19th century date. Indeed, the last miller is reported as finding a brick with the date of 1825 on it during some rebuilding work in the mid-20th century. The use of sandstone foundations may indicate that this block was rebuilt on an earlier structure. The complex included a 19th century mill house and a second small building of probable late 18th/early 19th century date; the fabric of both of these structures showed evidence of more than one phase of building. The rest of the buildings (hoist, loading bays, storage facilities, and a grain silo) dated from the mid-20th century, probably the period 1935 to 1950. The power system survived in the main mill building in the form of steel line-shafting and belt drives run from a wheelhouse with a sandstone-lined wheelpit showing evidence for at least two water wheels. In 2000, however, a late-19th century Francis Water Turbine was still in place along with its supporting gas engine manufactured by the National Oil Company, together with the weir and sluice system of the head-race. This turbine can be seen at the Anson Engine Museum, Higher Poynton.

use of cast iron columns as supports is reminiscent of textile mill building from the late 18th/early 19th century. The use of sandstone foundations may indicate that this block was rebuilt on an earlier structure. The present complex also includes a 19th-century mill house and a second small building of probable late 18th/early 19th-century date; the fabric of both of those structures shows evidence of more than one phase of build. The rest of the buildings (hoist, loading bays, storage facilities, and a grain silo) date from the mid-20th century (probably the years 1935 to 1950). The mill building complex survives intact, with all the major elements of the milling process present except for a drying kiln. The power system survives in the main mill building and is in a remarkably complete condition, comprising not only a Francis Water Turbine with its supporting National oil engine and belt drives, but also, externally, the weir and sluice system of the head-race.
